**Flood Control Project Maintenance  
Levee Inspections**

**Maintenance Issue Types Only, Levee Inspection Report By Mile - Fall 2018**

**Sutter Maintenance Yard Maintenance Area 0005**

Waterway	Bank	Unit Miles	Inspection Start/End	Inspector
Unit No. 01 Butte Creek	Left	15.08	10/30/2018 10/30/2018	Bob Duffey

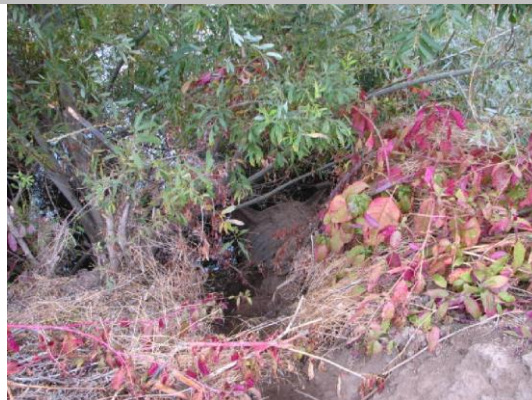
Photo 1 of 3 : UCIP\_FA\_2018\_53009\_68497.jpg

FIELD\_STRUCT\_DESC: 36-inch corrugated metal drainage pipe through the levee, 17 feet below the crown. Flap gate on the waterside (WS). Slide gate on the landside (LS) toe. Concrete headwalls at both the LS and the WS toes. [Additional Reference(s): DWR Levee Log, 1990. USACE Sacramento O&M Manual 515, (Station 902+50). USACE As-Built Drawing No. 50-4-2637, Exhibit B, Sheet 5, April 1950, (Station 902+50)].  
FS Date: 10/5/2018 11:20:19 AM

Flap gate on WS slope.

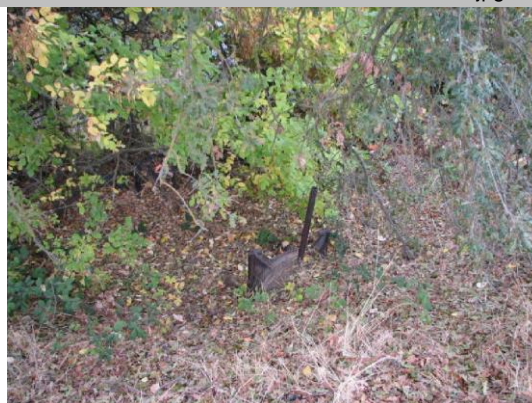
Photo 3 of 3 : UCIP\_FA\_2018\_52014\_68062.jpg

Comment Code						
Inspector Comment						
FS_ID:52014 DS_ID:1647 EP_NO: N/A Repair Type: No Action Needed Crossing Status: Found UCIP Comments: 5/18/2017 Crossing appears to be in good condition. Tree near the LS screw gate could use some trimming. Pipe has been selected to be internally cleaned and inspected as part of the DMP project. (DWR Sutter Yard- AFreitag)11/14/2016 Crossing appears to be in good condition. (DWR Sutter Yard- AFreitag)5/23/2016 Crossing appears to be in good condition.7/28/2015 Pipe appears in good condition. No noticeable issues to report.6/6/2013 Same as last inspection.11/12/2013 Same as last inspection.6/04/2014 Same as last inspection.11/25/2014 Same as last inspection. FIELD_STRUCT_DESC: 30-inch corrugated metal drainage pipe through the levee, 14.3 feet below the crown. Slide gate on the landside (LS). Flap gate on the waterside (WS). Concrete headwall at the LS toe. Concrete splash apron on the WS. [Additional Reference(s): DWR Levee Log, 1990. USACE Sacramento O&M Manual 515, April 1955, (Station 5+20""A"""). USACE As-Built Drawing No. 50-4-2637, Exhibit B, Sheet 4, April 1950, (Station 5+20""A""").]. FS Date: 6/1/2017 9:47:13 AM

Flap gate at outlet on WS berm.

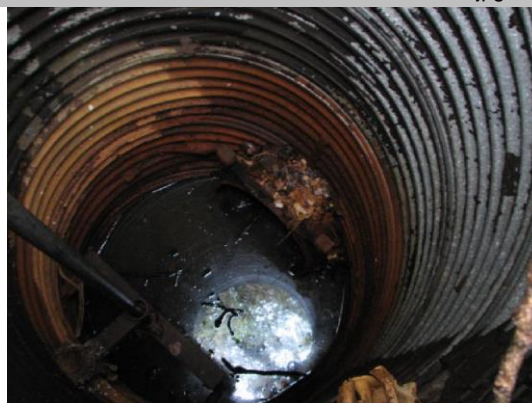
Photo 1 of 2 : UCIP\_FA\_2018\_52042\_68105.jpg

Slide gate and flap gate inside CMP riser on WS berm.

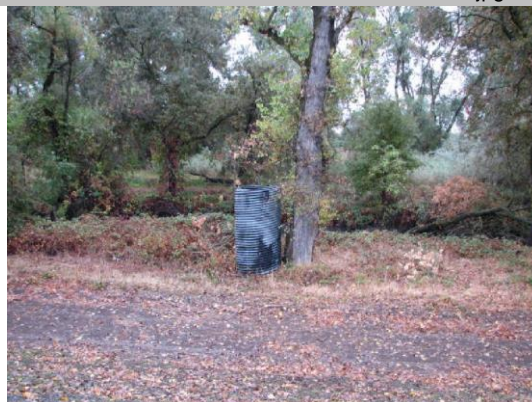
Photo 2 of 2 : UCIP\_FA\_2018\_52042\_68104.jpg

56-inch CMP riser on WS berm.

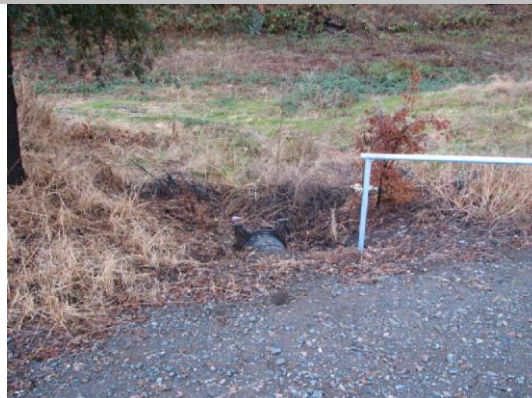
Photo 1 of 3 : UCIP\_FA\_2018\_52049\_68122.jpg

Flap gate on WS toe.

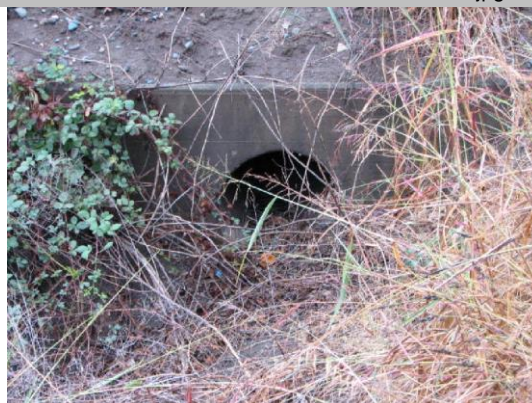
Photo 3 of 3 : UCIP\_FA\_2018\_52049\_68120.jpg

Comment Code						
Inspector Comment						
FS_ID:52049 DS_ID:1654 EP_NO: N/A Repair Type: No Action Needed Crossing Status: Found UCIP Comments: 5/18/2017 Crossing appears to be in good condition. Pipe has been selected to be internally cleaned and inspected as part of the DMP project. (DWR Sutter Yard- AFreitag)11/14/2016 Crossing appears to be in good condition. (DWR Sutter Yard- AFreitag)5/23/2016 Crossing appears to be in good condition. 7/28/2015 Crossing appears in good condition. No noticeable issues to report. 11/24/2014 Same as last inspection. 6/04/2014 Same as last inspection. 11/12/2013 Same as last inspection. 6/6/2013 Same as last inspection. FIELD_STRUCT_DESC: 24-inch corrugated metal drainage pipe through the levee, 9.4 feet below the crown. Flap gate on the waterside (WS). Concrete headwalls at both the landside (LS) and the WS toes. [Additional Reference(s): DWR Levee Log, 1990. USACE Sacramento O&M Manual 515, April 1955, (Station 627+00). USACE As-Built Drawing No. 50-4-2637, Exhibit B, Sheet 3, April 1950, (Station 627+00)]. FS Date: 6/1/2017 1:10:07 PM

Headwall on LS toe.

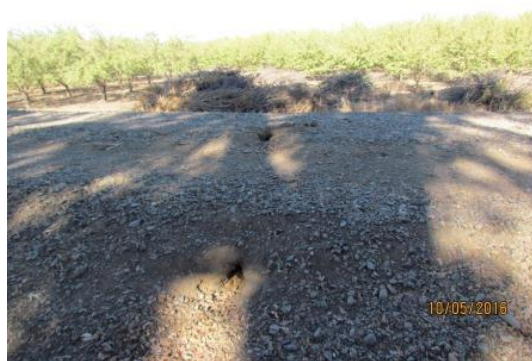
Photo 2 of 2 : FA\_2018\_MA0005\_197\_53\_20180905\_00026.jpg

LM Start	7.74	Rating **	U	Issue No.	53 (cont)	
LM End	7.74	Issue Type +	Ma	Location *	LS	
Category	Earthen Levee			GPS Latitude/Longitude		
				Start		End
Item	Animal Control			39.605088 °		39.605088 °
				-121.788569 °		-121.788569 °
DWR ID	DWR_MA0005_02_f_2016_53					
Comment Code						
A1 : Exterminate rodents and backfill and compact or grout burrows.						
Inspector Comment

View of the rodent holes along the crown and waterside slope.

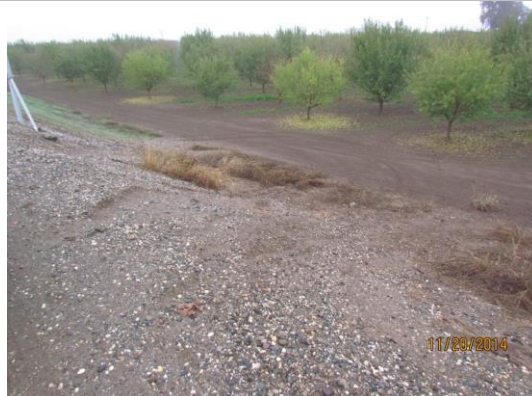
Photo 2 of 2 : FA\_2018\_MA0005\_197\_13\_20180905\_00006.jpg

LM Start	7.98	Rating **	M	Issue No.	13
LM End	7.98	Issue Type +	Ma	Location *	LS
Category	Earthen Levee			GPS Latitude/Longitude	
				Start	End
Item	Slope Stability			39.607710 °	39.607710 °
				-121.785868 °	-121.785868 °
DWR ID	DWR_MA0005_02_s_2012_13				
Comment Code					
S3 : Repair the levee slope damaged by vehicle traffic and prevent access where possible.					
Inspector Comment

View of the vehicle erosion along the landside slope.

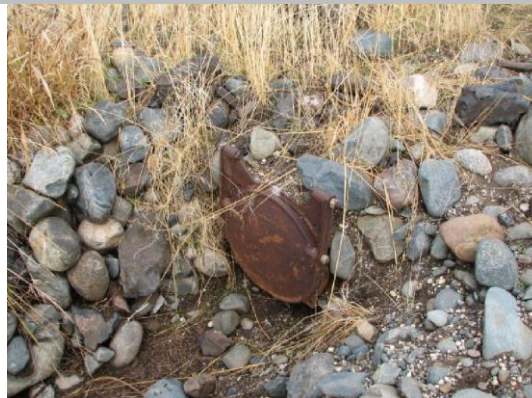
Photo 1 of 2 : UCIP\_FA\_2018\_52052\_68129.jpg

Comment Code					
Inspector Comment					
FS_ID:52052 DS_ID:1656 EP_NO: N/A Repair Type: Non-Urgent Crossing Status: Found UCIP Comments: 5/18/2017 LS inlet is almost completely full of soil. Pipe has been selected to be internally cleaned and inspected as part of the DMP project. (DWR Sutter Yard- A Freitag)11/14/2016 LS inlet almost completely full of soil. (DWR Sutter Yard- A Freitag)5/23/2016 LS end is almost completel full of soil.7/28/2015 Pipe is still over 3/4 full of soil. 11/24/2014 Same as last inspection.6/04/2014 Same as last inspection.11/12/2013 Same as last inspection.6/6/2013 Same as last inspection.10/31/2012 Pipe 3/4 full with soil on LS. FIELD_STRUCT_DESC: 24-inch (not 18-inch as shown in as-built drawing) corrugated metal drainage pipe through the levee, 6.7 feet below the crown. Concrete headwall at the landside (LS) toe. Flap gate on the waterside (WS). [Additional Reference(s): DWR Levee Log, 1990. USACE Sacramento O&M Manual 516, April 1960, (Station 379+98). USACE As-Built Drawing No. 50-4-2637, Exhibit B, Sheet 2, April 1950, (Station 550+60)]. FS Date: 6/1/2017 1:15:55 PM

Flap gate at WS toe.

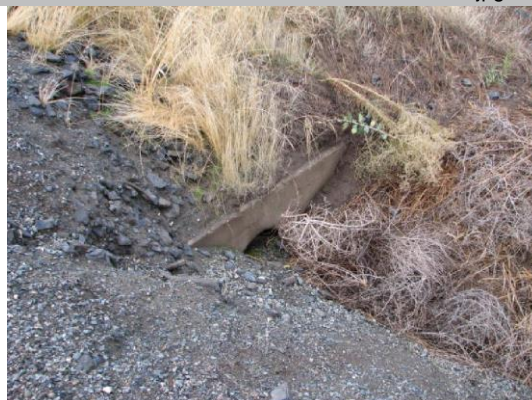
Photo 2 of 2 : UCIP\_FA\_2018\_52052\_68128.jpg

Concrete headwall on LS toe.

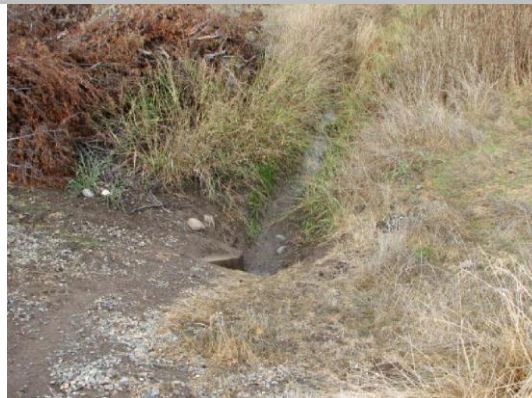
Photo 1 of 3 : UCIP\_FA\_2018\_52061\_68397.jpg

FS\_ID:52061  
DS\_ID:1663  
EP\_NO: N/A  
Repair Type: No Action Needed  
Crossing Status: Found  
UCIP Comments: 5/18/2017 Crossing appears to be in good condition. Pipe has been selected to be internally cleaned and inspected as part of the DMP project. (DWR Sutter Yard- A Freitag) 11/14/2016 Crossing appears to be in good condition. (DWR Sutter Yard- A Freitag) 5/12/2016 Crossing appears to be in good condition. 7/30/2015 Crossing appears in good condition. No noticeable issues to report. 11/24/2014 Same as last inspection. 6/4/2014 Same as last inspection. 11/13/2013 Damaged pipe section was dug up and replaced. New WS flapgate with u-shaped wingwall installed on end of pipe. 6/6/2013 Same as last inspection. Plans have been made to repair during summer of 2013 before high water season. 11/01/2012 Pipe rusted through along bottom at WS outlet. Sink hole over pipe on WS berm. WS headwall eroded eternally around backside of headwall.

Concrete U-shaped headwall on LS toe.

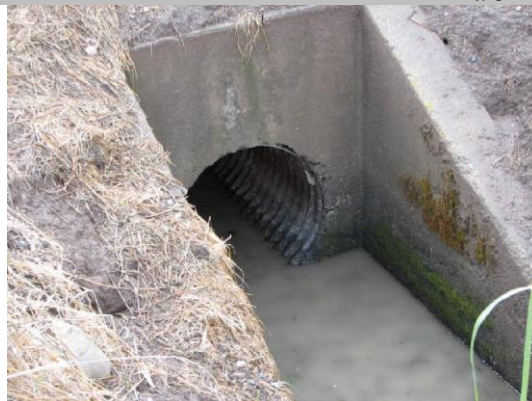
Photo 2 of 3 : UCIP\_FA\_2018\_52061\_68396.jpg

Concrete U-shaped headwall on LS toe.

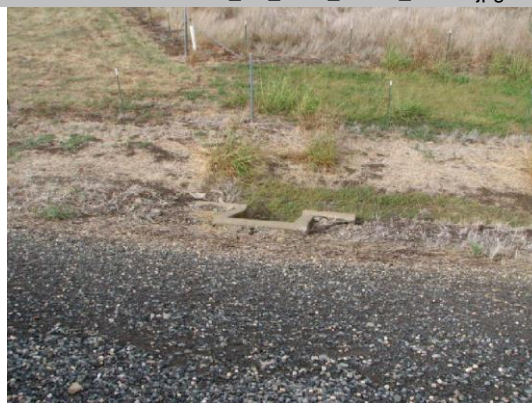
Photo 2 of 3 : UCIP\_FA\_2018\_52063\_68412.jpg

Concrete U shaped headwall on LS toe.

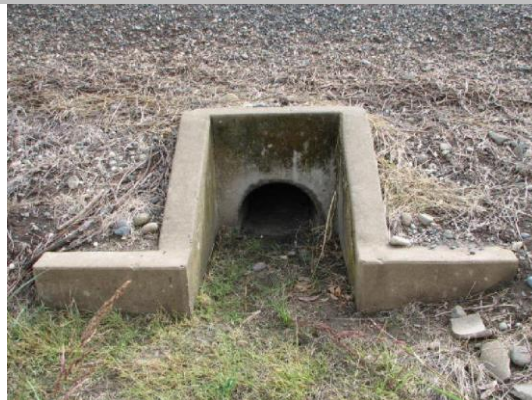
Photo 3 of 3 : UCIP\_FA\_2018\_52063\_68411.jpg

Concrete U shaped headwall on LS toe.

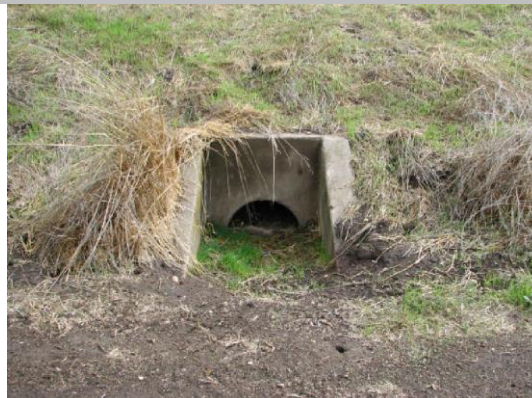
Photo 3 of 3 : UCIP\_FA\_2018\_52064\_68415.jpg

Concrete U-shaped headwall on LS toe.

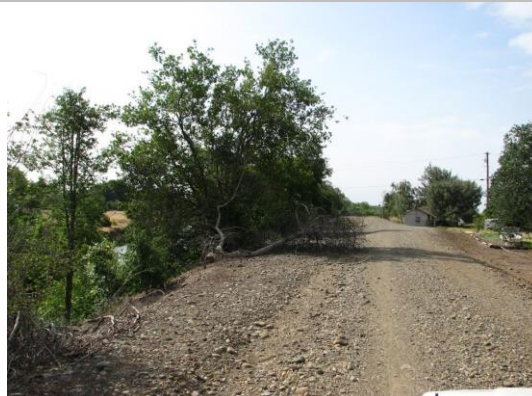
Photo 1 of 1 : FA\_2018\_MA0005\_197\_38\_20180905\_00014.jpg

LM Start	14.39	Rating **	M	Issue No.	38
LM End	14.39	Issue Type +	Ma	Location *	WS
Category	Earthen Levee			GPS Latitude/Longitude	
				Start	End
Item	Encroachments			39.692284 °	39.692284 °
				-121.779394 °	-121.779394 °
DWR ID	DWR_MA0005_02_s_2016_38				
Comment Code					
TR : Tree or limb					
Inspector Comment					
Fallen trees on WS slope of levee.

5/5/2016: Remove fallen tree from WS slope.

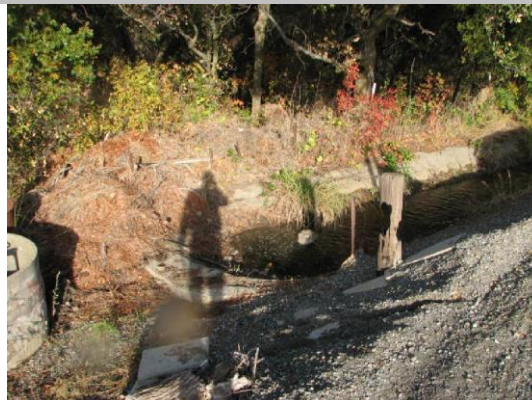
Photo 2 of 3 : UCIP\_FA\_2018\_52086\_68543.jpg

Concrete lined channel on LS toe.

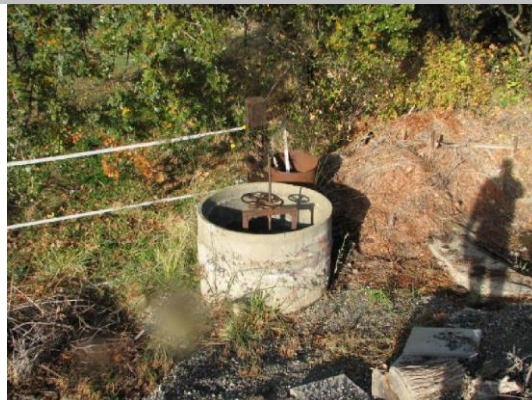
Photo 3 of 3 : UCIP\_FA\_2018\_52086\_68542.jpg

Concrete standpipe and slide gate on LS toe.

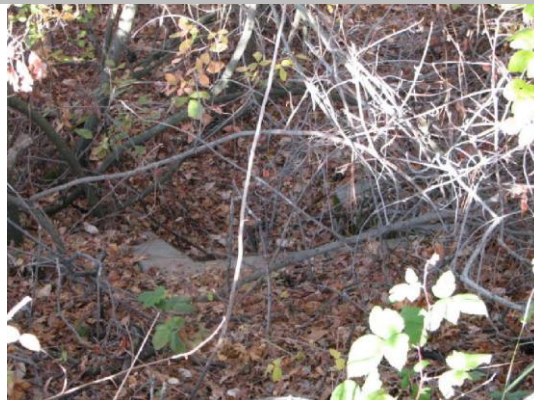
Photo 1 of 2 : UCIP\_FA\_2018\_52087\_68541.jpg

Comment Code					
Inspector Comment					
FS_ID:52087 DS_ID:1683 EP_NO: N/A Repair Type: Non-Urgent Crossing Status: Found UCIP Comments: 5/18/2017 WS appears to be in good condition. LS inlet is across a ditch and inaccessible for inspection due to dense vegetation and being down a very steep slope. Pipe has been selected to be internally cleaned and inspected as part of the DMP project. (DWR Sutter Yard- A Freitag)11/14/2016 Crossing appears to be in good condition. (DWR Sutter Yard- A Freitag)5/11/2016 Crossing appears to be in good condition.8/3/2015 Crossing appears in good condition. No noticeable issues to report.6/6/2013 Same as last inspection.11/13/2013 Same as last inspection.6/4/2014 Same as last inspection.11/25/2014 Same as last inspection. FIELD_STRUCT_DESC: 24-inch corrugated metal drainage pipe through the levee, 14.3 feet below the crown. Concrete ""U"" headwalls on both the landside (LS) and the waterside (WS). Flap gate on the WS. Inlet downhill from a concrete lined channel at the low point on the LS toe. [Additional Reference(s): DWR Levee Log, 1990. USACE Sacramento O&M Manual 516, April 1960, (Station 36+85)]. FS Date: 6/1/2017 2:14:24 PM

Inlet at LS toe.
